High Performance Home Case Study

High Performance Housing with Gerber Homes: A Case Study

The Design Home

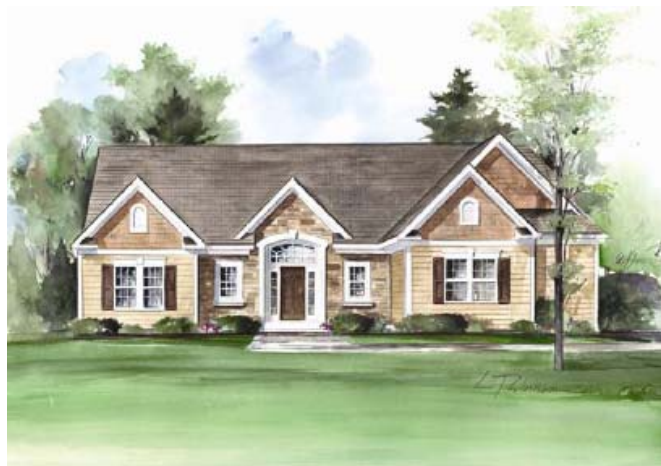
Figure 1. Front Elevation of Gerber's *Build-Green, Live-Green* Homerama Home located at 11 Tea Olive Lane, Magnolia Manor, Rochester, NY

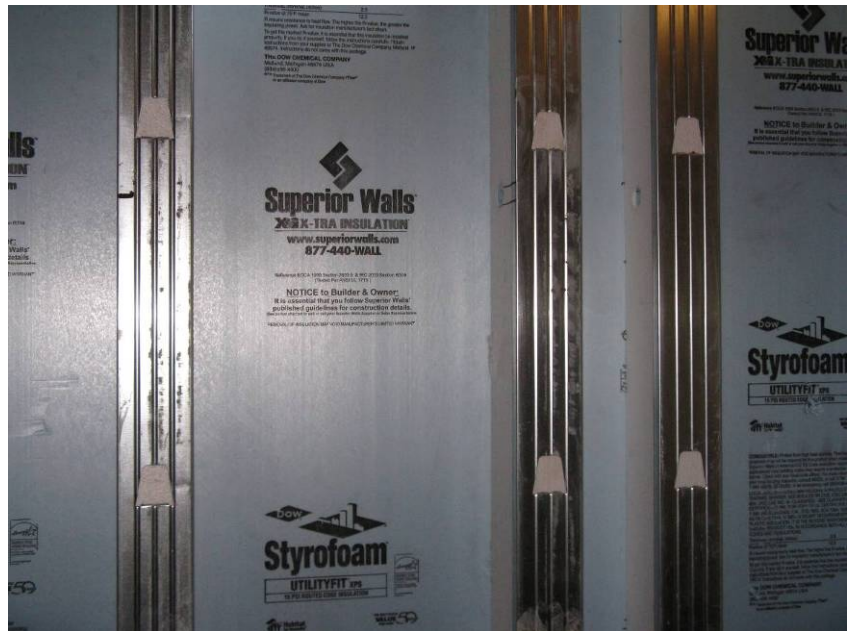
Figure 3. Superior Walls Basement Walls

Basement Walls: Energy simulation modeling shows that a typical new NY home's standard basement wall system can account for as much as 27% of the home's heat loss. The Build Green, Live Green's advanced basement wall system is projected to save 14% of the entire home's energy use compared to a standard basement wall system. To achieve a super-insulated basement, Superior Walls' pre-cast concrete walls with integrated

R-12.5 continuous insulation provided the support. Then Owens Corning's high-density R-21 fiberglass insulation was installed in the wall cavities. Because the basement is unfinished, Owens Corning's permeable house wrap, PINKWRAP®, was specified as the interior finish for its clean and non-abrasive surface that far outperforms code requirements for flame spread and smoke developed index.

Insulating and air sealing an unfinished basement can be a challenge. When a contractor thinks basement insulation, he typically thinks R-11, hanging 4' down from the sill plate of a poured concrete or concrete masonry foundation wall. The Gerber home called for precast concrete walls with integrated and continuous polyisocyanurate foam at R-12.5. To boost the whole wall R-value to R-33.5, the specification called for installation of R-21 in the 2x6 cavities of the precast concrete wall. What seemed like it should take a couple simple steps turned into several. Un-faced fiberglass batts would need to be used to meet the smoke density and flame spread requirements of code. Though the un-faced batts conformed to code, local building code inspectors asked that a finish layer be applied over the batts due to concerns about ambient fibers. Because kraft faced batts would not meet smoke and flame requirements of code, a foil or poly scrim kraft is generally used for this application. Non-perforated scrim kraft finishes have a very low permeability (~0.02 perms) that do not permit the wall to dry to the interior when there is bulk moisture penetration. Owens Corning, who supplied the R-21 batt, suggested their PINKWRAP housewrap product for the finish, which provides a higher perm while performing far better than code requirements as related to smoke and flame. Ultimately, code officials rejected the house wrap as an interior finish due to the product not being labeled as an interior wrap, and the builder was forced to settle for a PSK finish for the below grade walls.

When it came time to actually install the batts, insulation installers were faced with highly irregular stud spacing in the precast concrete walls. "Standard" stud spacing within the walls was given as 24 inches on center, meaning the standard cavity was 19.75 inches wide, once stud width and foam board insulation were accounted for. A large number of the cavities were much smaller than the 19.75 inches – at dimensions of 11 or 9 or 7 inches, which would require trimming all batts to various dimensions to avoid compression and to maintain their rated R-value. All said, the low hanging fruit of basement insulation required coordination between manufacturers, code official, builder, and contractor, with the final installed system unable to provide the same performance as the specified system, due to building official concerns over product labeling.

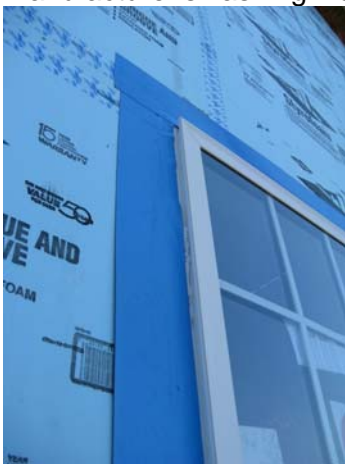
Figure 4. Dow Styrofoam for exterior continuous insulation

In specifying an above grade wall with continuous extruded polystyrene on the exterior and high density spray foam in the interior cavities, it was crucial to detail the flashing around windows and penetrations to avoid future problems with bulk water movement through the assembly. Joints and seams of exterior foam board were taped to result in a code compliant weather barrier, and a Dow representative was on-site to ensure that manufacturer's flashing instructions were followed explicitly during the installation.

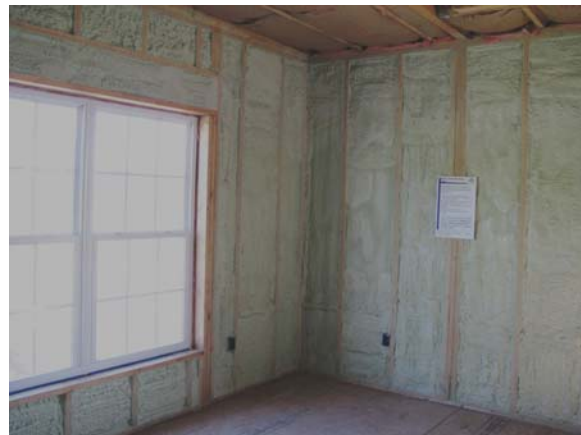
Figure 5. BASF Comfort Foam cavity insulation

Above Grade Walls: Energy losses through above grade walls account for about 15-25% of the heat load of a typical NY home. To reduce expected heat loss, the first step was to reduce the amount of framing in the wall, by spacing the studs at 19.2 inches on center (the diamond mark on a tape measurer), and using ladder blocking and two stud corners. Reducing the framing members in this fashion means more insulation can be installed in the walls. The Gerber home has both continuous exterior insulation and interior wall-cavity insulation on above-grade walls. Two-inch Dow Styrofoam, rated at R-10, was installed on the outside of the OSB structural sheathing. To help provide a tighter wall assembly while increasing insulation, BASF Comfort Foam was sprayed in all cavities and along band joists, providing a cavity insulation R-value of 18.3. Together, these measures are projected to reduce the home's total energy use by 8%. Improved air sealing resulting from these measures could increase the projected energy savings by another 3%.

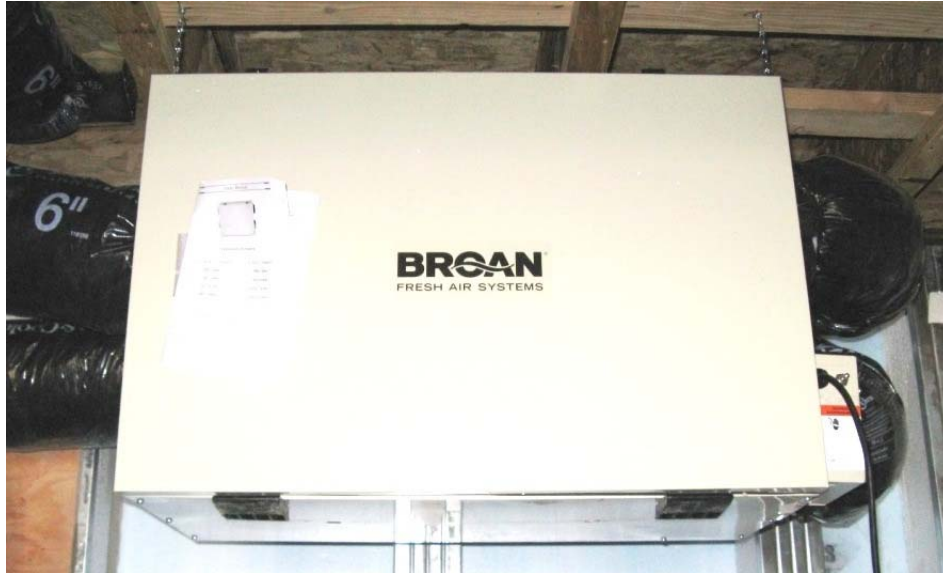
Figure 6. Broan HRV100h for indoor air quality. Note the two 180 degree bends in the supply and return ducts on the right hand side.

For the Gerber home, the "Cadillac" of all installations was selected – a system configured to pull from the three bathrooms in the home and supply to the return plenum of the central duct. Though a smaller model HRV could have been selected to provide the target ventilation rate (based on ASHRAE 62.2 levels), a larger volume unit was selected to permit the HRV to operate at lower speeds and higher efficacies. Variable fan speed and humidistat controls were installed in the bathrooms to boost the HRV from low to high speed during high demand events. With the unit sized to pull over twice the targeted air flow of the home, it was expected that it would operate on medium speed. Field measurements of air flow taken with a digital thermo anemometer (Dwyer Series 471), resulted in fan speeds that fell short of design levels. Though the digital thermo anemometer was selected for its reputed high accuracy, field measurements showed a high degree of variability based on position within the duct. For this reason, no measurements are reported here. Nevertheless, based on low numbers that were reported by the anemometer, the HRV was left on the high speed setting to maximize flow through the ducts.

It is suspected that the layout of the HRV supply and return ducts contributed to the low flow measurements recorded. This was especially true of the return side of the HRV, which consisted of a 6" flex duct with runs from 3 bathrooms. The longest of these runs was 80 feet and included eight 90 degree bends, one 180 degree bend, and one tee. The HRV's supply duct was characterized by 32 feet of 6" flex duct, two 90 degree bends, and two 45 degree bends.

The lesson learned from this install is that what looks good on paper doesn't always play well in the field. The simple solution may be the best, and placement of the HRV and its ducting system should be done through balancing considerations of both anticipated expansion/basement finishing as well as performance of the unit. Further, actual supply and return flow rates of these units can be expected to fall far short of manufacturer's published data due to high static pressure associated with typical installations.

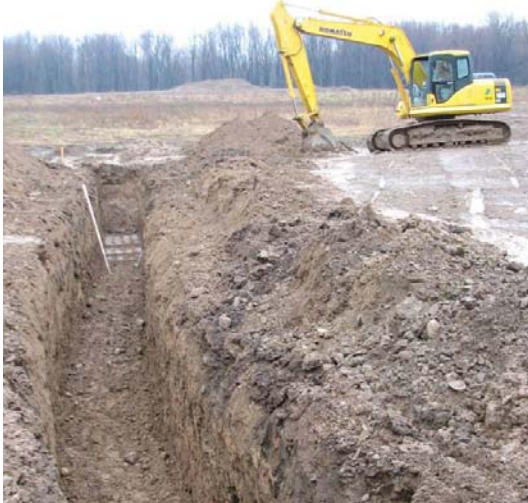
Figure 7. Excavating for the horizontal geothermal loop field. A horizontal installation was selected as a more affordable alternative to a vertical loop field.

13. The Gerber home uses a ground source heat pump to improve the home's heating and cooling energy efficiency. Water Furnace Envision's high efficiency ground source heat pump is expected to provide between a 40 percent to 45 percent reduction in total energy use from a baseline code compliant home.

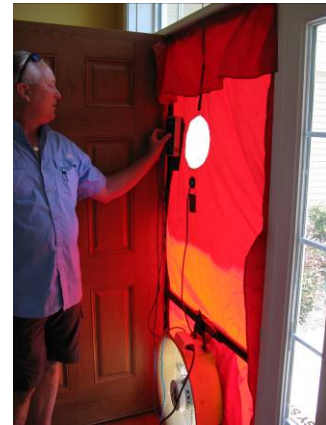
Figure 5. Blower door test.

Tighter homes consume less energy through reduction of unwanted convective heat loss and gain. A blower door test was conducted on the home to quantify air infiltration. This value can be used to calibrate models of the home to better estimate expected heating and cooling energy use.

Typically, new single family detached construction results in infiltration levels of 5-7 air changes per hour (ACH) at 50 Pascals. With high density spray foam used to seal the above grade walls, band joists, and penetrations, this home was expected to perform much better than a standard home. The blower door test was subcontracted to a HERS rater who reported an infiltration rate of 2.0 ACH at 50 Pa for the home.
